# CASE STUDY

## DAVIT ARM PADEYE MACHINING

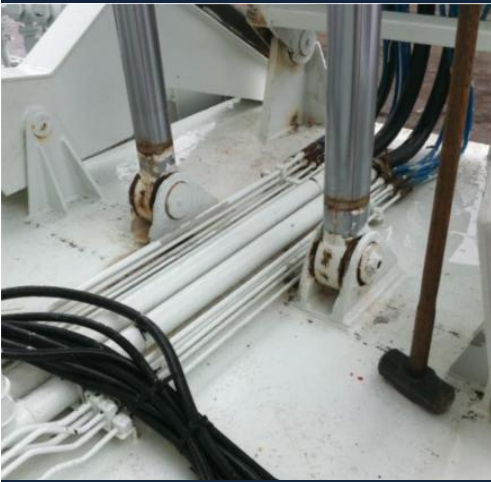
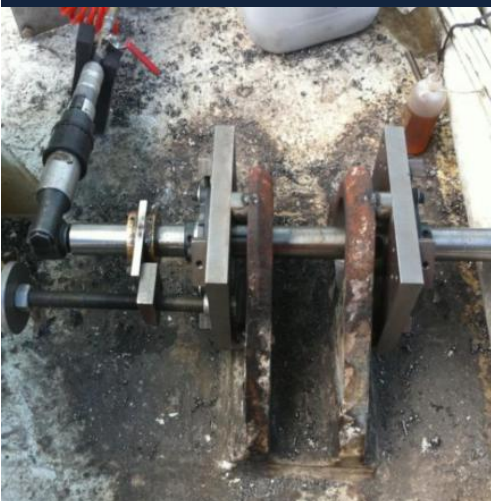
A North Sea offshore supply vessel experienced significant wear on the locating pins and padeye bushes of its lifeboat launching davit arms. This wear created excessive strain on the hydraulic system and raised safety concerns about reliable lifeboat deployment.

Two sets of custom line boring machines, along with highly experienced MOSS technicians, were mobilised so that both pairs of padeyes could be machined simultaneously.

The old bushes were carefully removed, and the padeye bores were precision-machined to accept new bushes.

Once the bushes were welded into place, the line boring rigs were reinstalled and the bores machined in-line to achieve an exact running fit for new location pins.
